Rear Muffler Panel “Rust” on 2014 C7 and 2017 Grand Sport

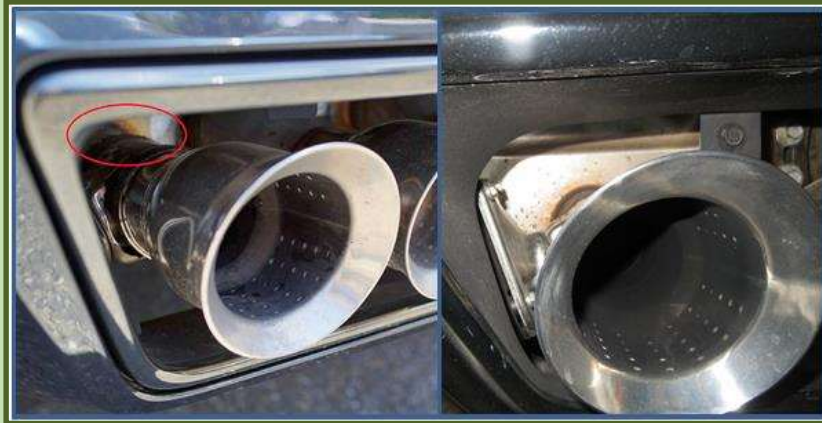
A forum poster asked about the brown stain he observed on the rear panel of his mufflers (red circle picture left.) I recalled seeing the same brown stain in a number of areas on my C7. I responded to his post indicating I used a product called Rust-Olium

Rest Reformer to change the brown, “rust” black (the picture right is a similar area I coated 6 months ago.) These products have been sold for many years. They convert iron oxide (rust) to iron titanate using tannic acid and pH adjusters. This product also contains barium sulfate and a future rust inhibitor.

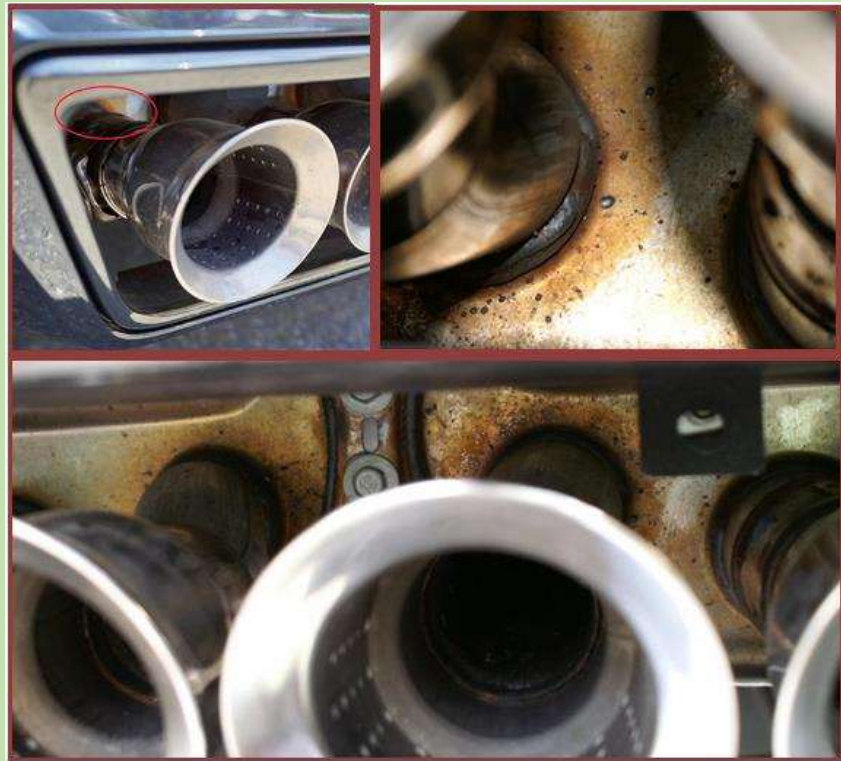
Several others posted even greater amounts of rust and were planning to add a an exhaust cover plate so it wasn't visible. The picture right shows the original posted brown spot and those posted by others. In fact, I recall this issue was brought up when the original fleet of test C7's were observed. I even saw some rust on rear panel on the first C7's I saw, at Laguna Seca in August of 2013. The back panel has a lot of press forming that may thin the aluminized surface. It also has large pipe welds and weld spatter that no doubt melted the thin aluminized surface exposing uncoated places of 409 stainless that quickly starts to rust.

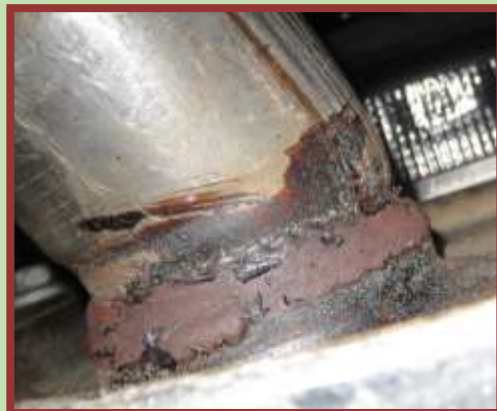
The most heavily rusted areas were the welds and the weld spatter on the back panel. These, of course, are not aluminized. The exhaust supplier probably used a 409 welding wire so the welds will not rust any more than an

uncoated 409 steel. However the aluminized material remains rust free much longer.

Although not readily visible from the rear, when looking under the car I did notice significant rust on the welds attaching the exhaust tip pipes to the back panel. The photo right shows one of these rusted welds on my C7.

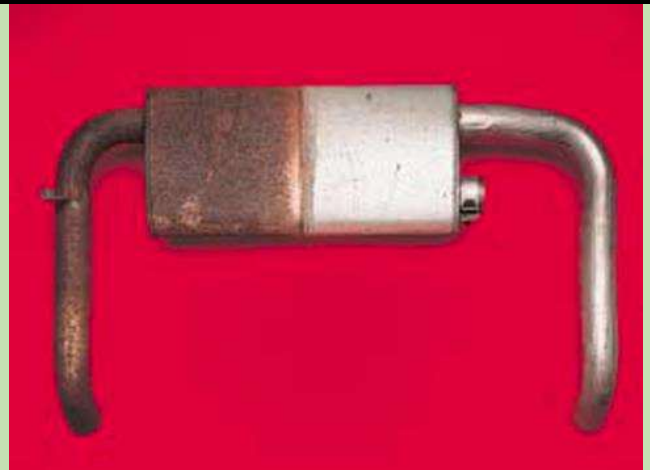
A manufacturer of aluminized 409 stainless made this muffler to show a comparison between aluminized 409 stainless steel (right) and non-aluminized material (left.) The muffler was exposed to accelerated exposure. This appears to be a severe exposure such as a salt water environment, simulating salted roads. The aluminizing process is done on the sheet material, welds, which occur after manufacture, are not coated.

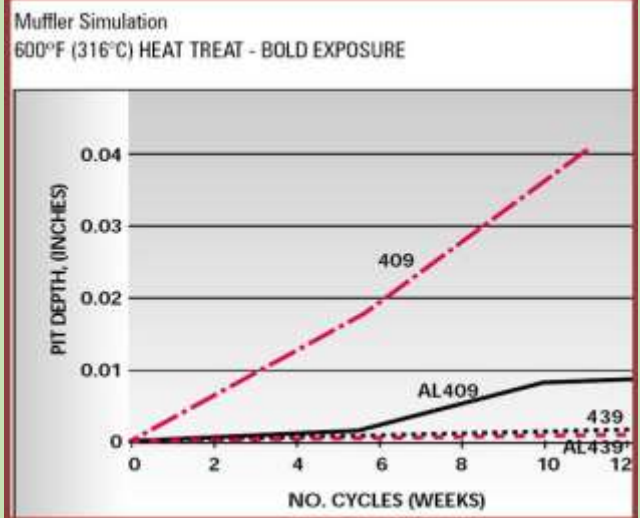
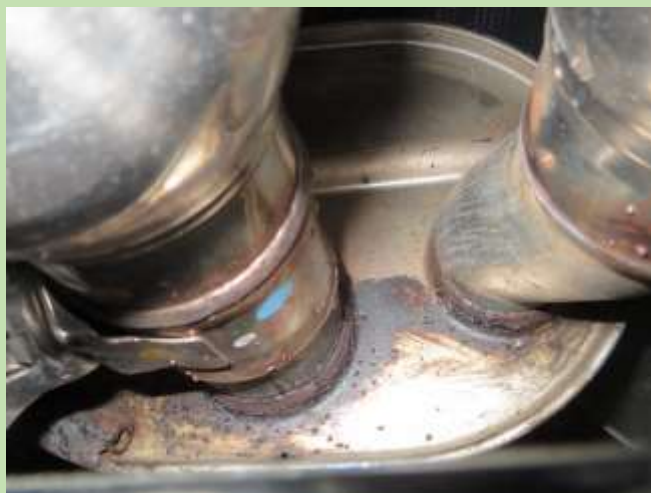
This is a graph provided by the aluminized stainless steel manufacturer showing what they referred to as bold exposure. It quantifies corrosion by measuring and plotting the depth of pits that form over the exposure time. Note the aluminized 409 stabilized at under 0.01 inch deep pits while the uncoated material progressively formed deeper pits. Plain carbon steel would be significantly worse.

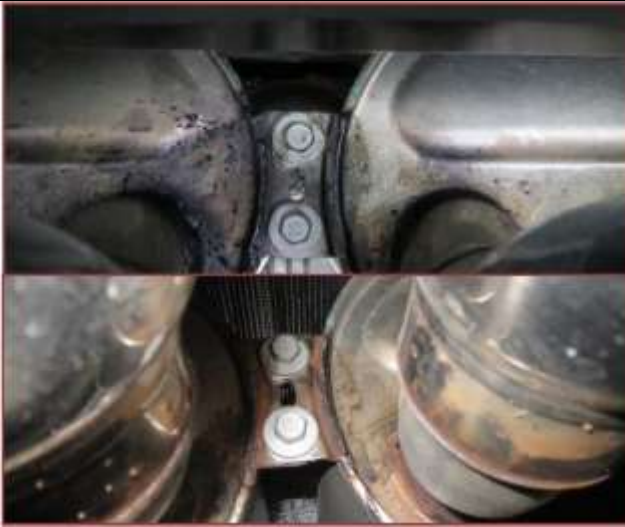
This is a before (lower picture) and after 2 hours of being coated (upper picture.) All rusted areas are now a dull black.

My experience with this type product indicates it may have to be repeated yearly to coat newly rusted areas. However, the process, unlike painting, is very quick.

The finished appearance is matt somewhat mottled black. It does not change the aluminized finish on the none rusted materials.

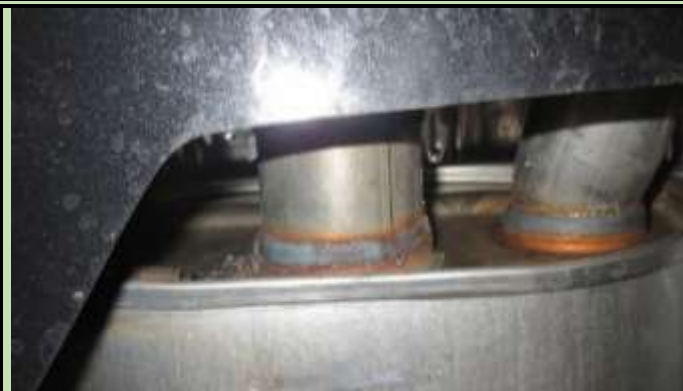
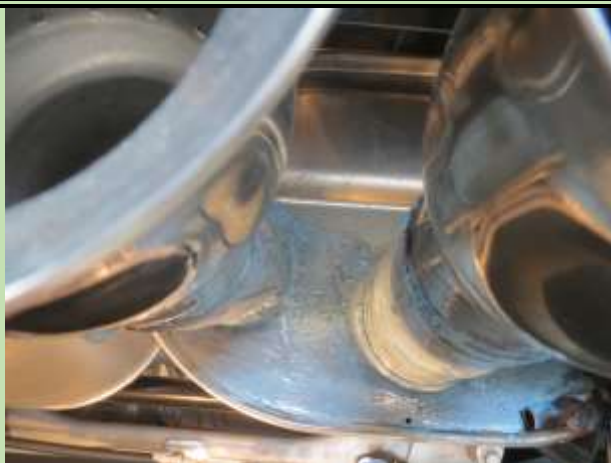
My 2-month-old Grand Sport looked about the same at my 2014 C7. The welds and the HAZ around the welds that removed the aluminized surface had rusted. It was not flaky rust so all that was needed was a quick wipe with a rag.

The same rust was on both mufflers. All on the welds and the weld HAZ (Heat Affected Zone) next to the weld. The heat melted the very thin aluminized layer on the 409-stainless steel.

Rust reformer applied with a brush taped to a dowel. Mostly all from the rear. It took less than 10 minutes.

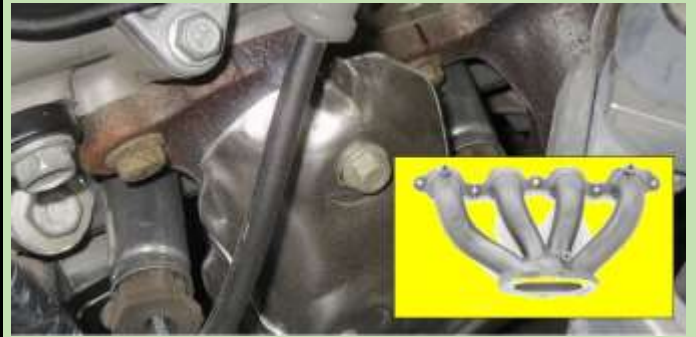
A forum poster complained about the rusty exhaust manifold on his new C7 with only 500 miles. The Vette has cast iron exhaust manifolds that will rust. Why not try the same Rust Reformer product used on the exhaust to change the rust to blue black color that will also help prevent further rust?

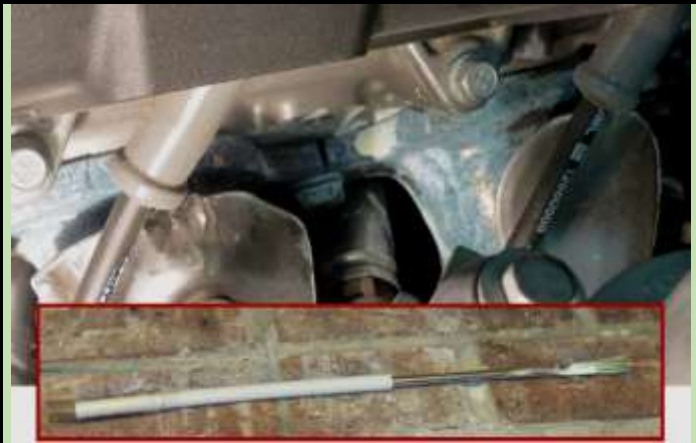
There was very little of the rusted manifold visible on the passenger side.

Rust Reformer as applied. As with the muffler it goes on very easy and you don't worry about brush strokes or getting some on non-rusted parts once dry. It does not show on non-rusted areas. Made the long-handled brush as before to gain access to all on the visible exhaust manifold areas on the driver's side.
