Shift Knob Feels Great, Looks Cool and Shortens Throw!

This “Cue Ball” size shift knob is available for the C7. Had the black one (left) on my Red 2014 Z51 C7 and installed the white knob (right) on my Artic White 2017 Grand Sport.

Install on 2014 C7

Install on 2017 GS

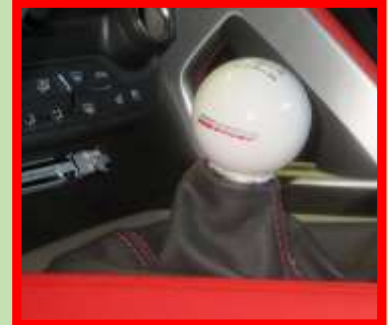
They are available in white or black with the 7 speed shift pattern and on the sides either Stingray image, the word Corvette and for my new 2017 Grand Sport.

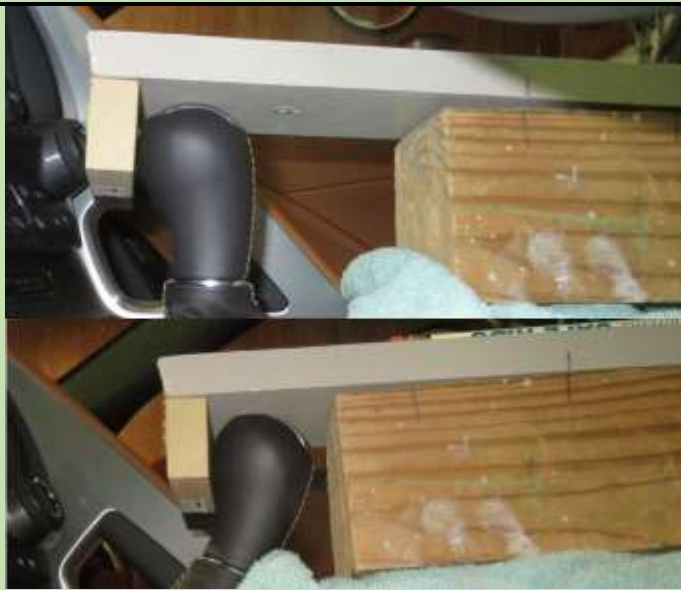
First task was to devise a way to measure the existing shifter throw. Decided since one often uses a cupped hand to pull the shifter back, the measurement method shown probably best defines the stroke. I used a section of wood that was perpendicular to the top board, simulating a cupped hand touching the knob. Marking the bottom block from the shift knob furthest forward to full back showed the standard shifter has a $2\frac{3}{4}$ inch throw.

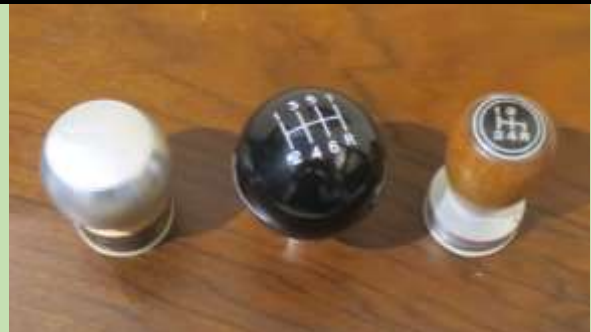
The knob is large, $2\frac{1}{4}$ inch diameter, the same size as a cue ball!

This picture shows a comparison with my desk paperweight knobs from my 1974 Datsun 260Z and a knob from a short throw B&M shifter installed in my S-10 truck some years ago.

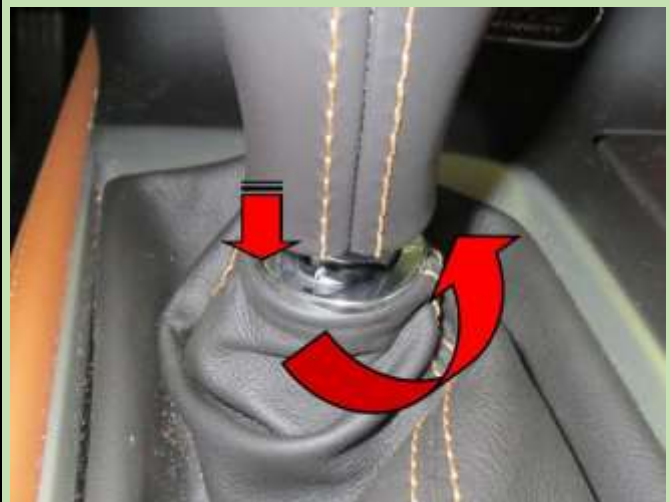
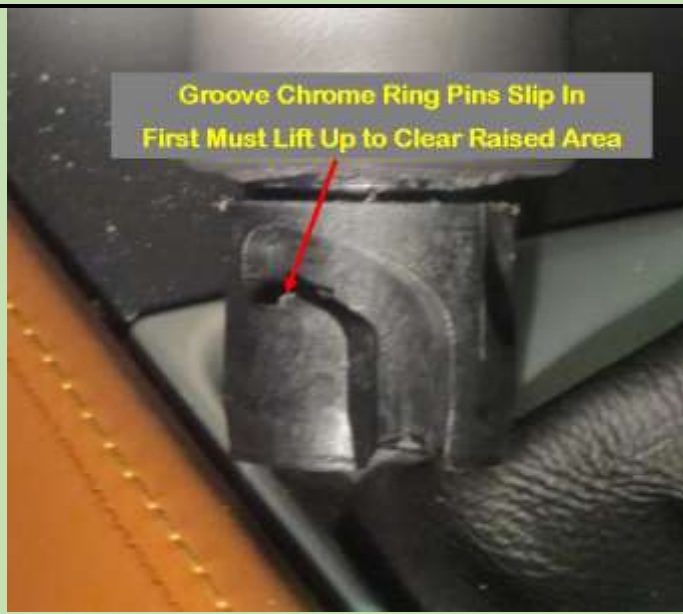
First, with the knob removed you can see the grooves that are on both sides of the OEM shift knob. That is the path two pins attached to the trim ring must follow it have it slide down to reveal the screw holding the knob in place.

There is a slight raised ridge (red arrow) that must be cleared before pressing the ring down in the groove. I think getting over that ridge was the problem I had because in my shifter the pins fit very tight in the grooves. Perhaps yours will have more clearance.

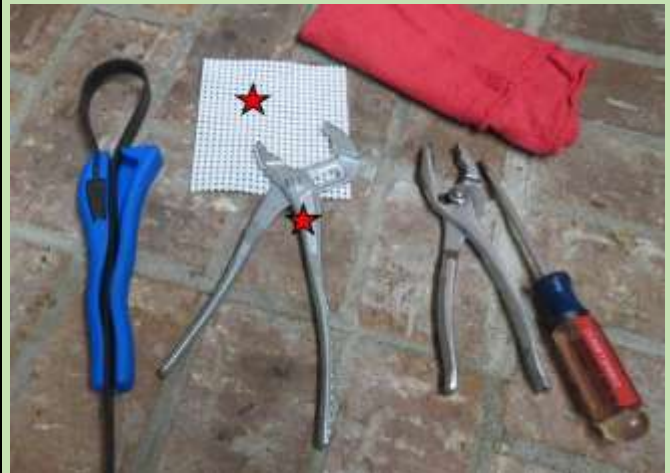
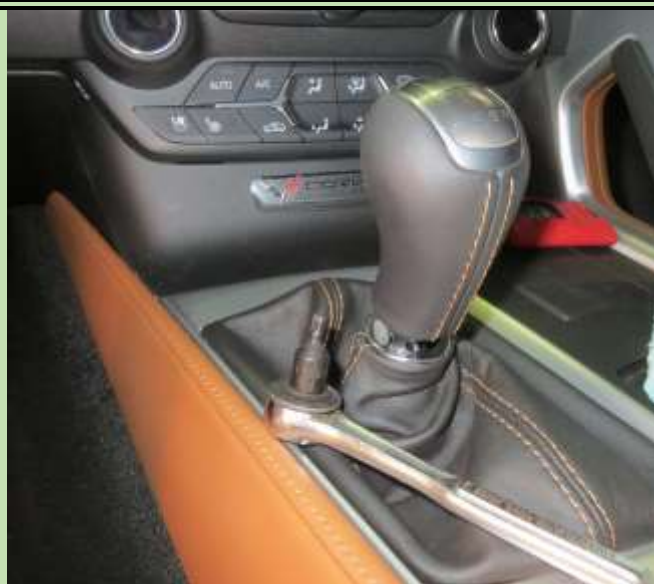
These are the tools I used trying to turn the trim ring! On the left is a rubber pipe wrench, which was not help. I even used a screw driver to leverage it down, don't do that, it won't help! Used a rag and the pliers shown next to the screw driver-no help. The best I could do was to get it to turn about 10 to 15 degrees when 90 degrees was needed!

Finally used the arc joint pliers (shown with the red star) and the jar friction pad (also shown with a red star.) The pad provided friction and well as protected the leather and chrome ring. It worked. Took quite a bit of force but it finally turned.

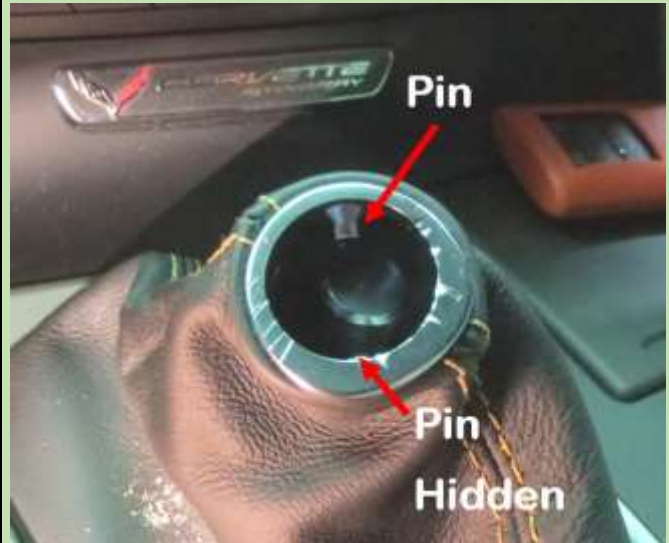
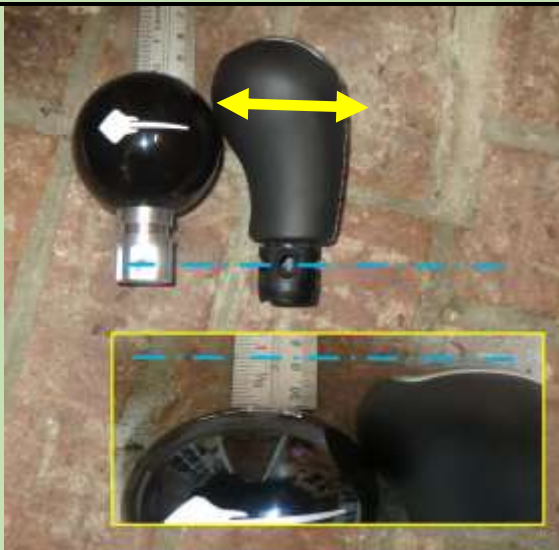
After the OEM knob was removed, this pic shows one of the pins that is part of the ring. There is a similar pin (hidden from view in this pic) on the opposite side.

Considering I also had some difficulty reinstalling the trim ring, I could have used an emery board and sanded both pins slightly to provide more clearance. Perhaps your pins will be easier to slide in the grooves.

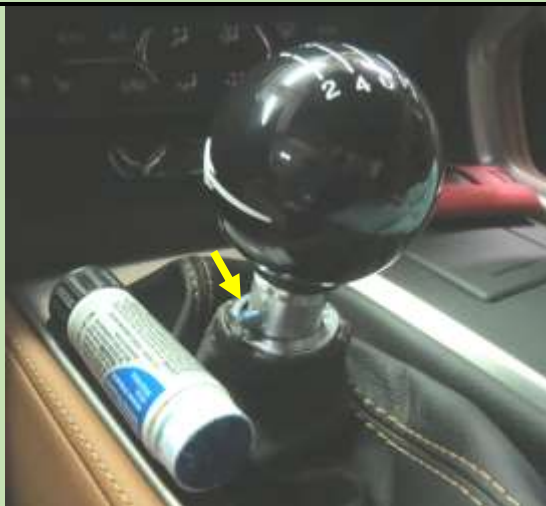
These are the two knobs side by side. Lining up the screw holes and measuring the max height shows about $\frac{3}{4}$ inches, not a full 1 inch height difference. The OEM knob is 2 inches wide and 2.07 inches front to back.

The new knob is $2\frac{1}{4}$ inch diameter. It feels fine in my hand. I don't have long fingers but the width for a glove measurement is $9\frac{1}{2}$ inches which is a large to extra-large glove size.

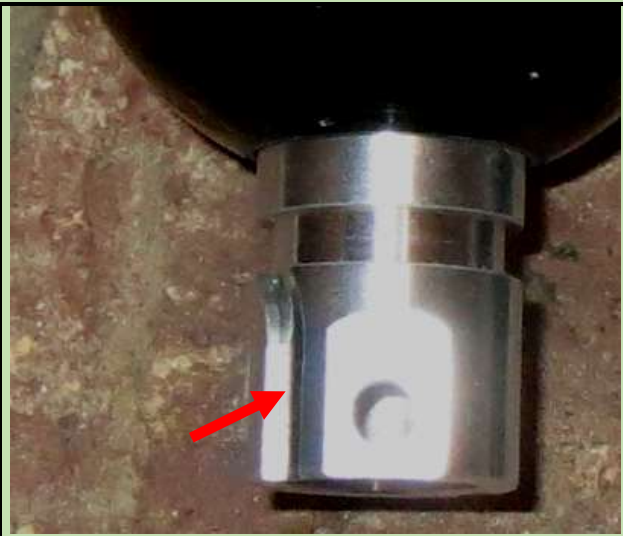
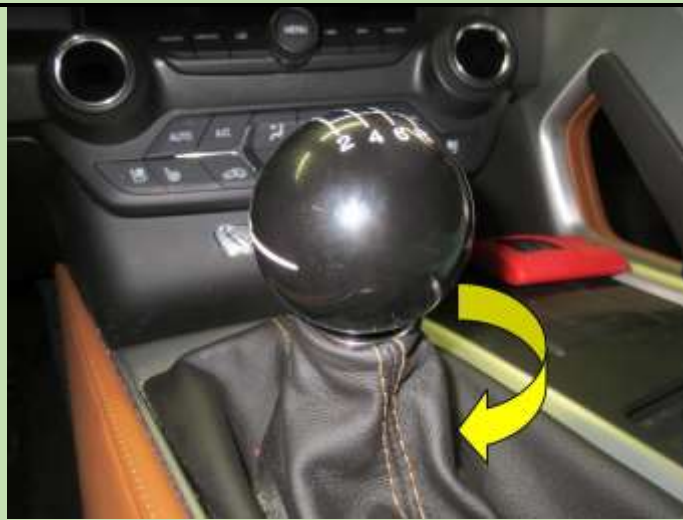
I put blue, medium strength Loctite on the screw that attaches the new knob to the shaft (yellow arrow.)

The new knob has the same two pin grooves as the OEM knob (red arrow.) The pins on the trim ring need to ride in these grooves as it is raised in position. The pins fit tight and required significant force to have them move up to the top. Just wiggle as you pull up.

Note the knob came with 3 "O" rings to choose from that slip above the pin groove. It helps keep the trim ring snug. The thinnest of the 3 was used and with the tight pin fit, not sure even if it was required.

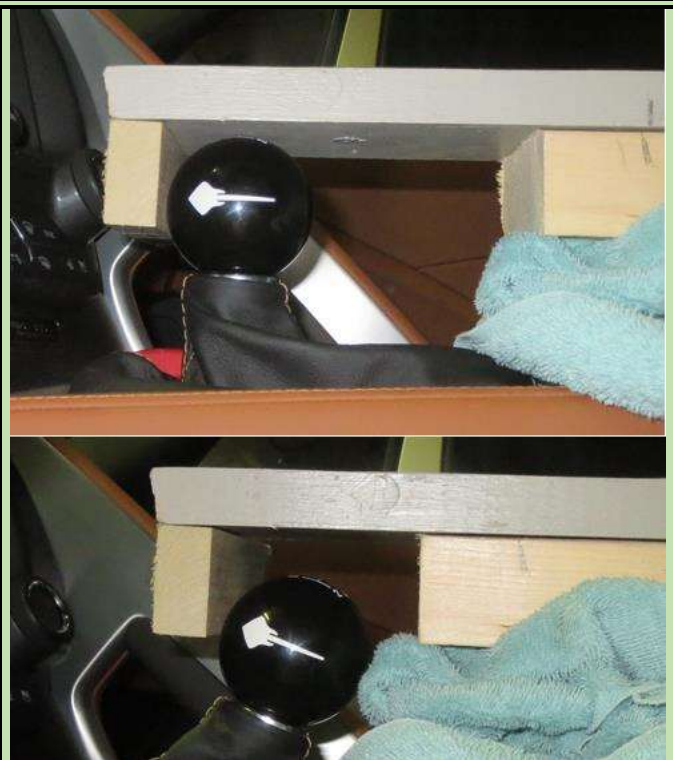
Measuring the shifter throw with the new knob shows it was $2 \frac{7}{16}$ inches. That is $\frac{5}{16}$ inches less than the OEM shifter or $0.31/2.75 = 11.4\%$ less.

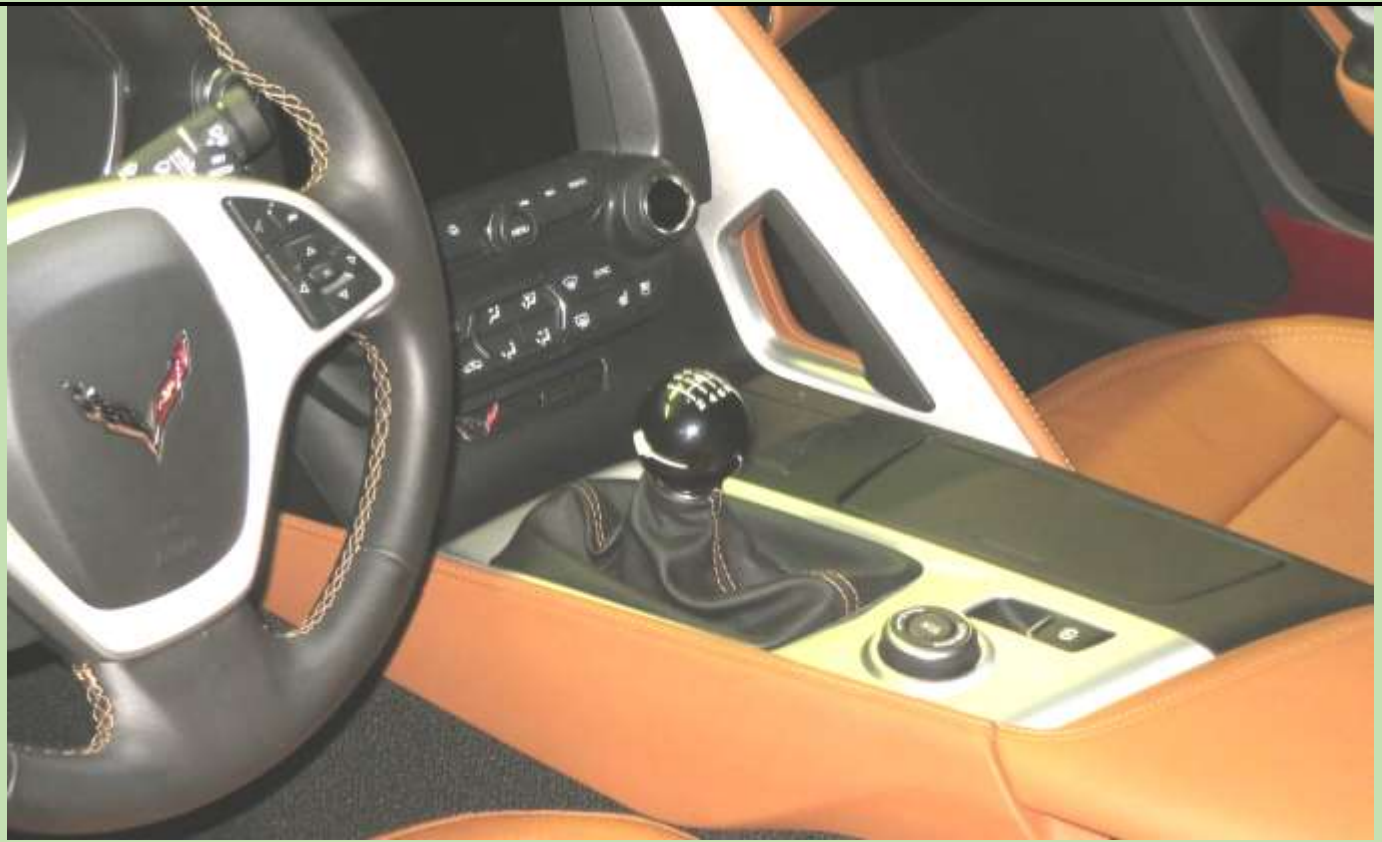
The final installation looks great. The black knob complements the interior trim.

After 7 months of use I defiantly would recommend this knob. It particularly makes the 4th to 5th shift and the 6th to 7th shift feel more positive. I also fine the 1st to 2nd shift when the trans is cold more positive as it does require more force until it warms up. 11.4% is not a lot of shift stroke reduction but it is noticeable. Someone questioned how the stock could be less since it didn't change the pivot point as is done with aftermarket shifters. I relayed what we did with column shift 3 speeds that I drive as a teenager! We would grab the lever close to the steering column and have a very short throw!

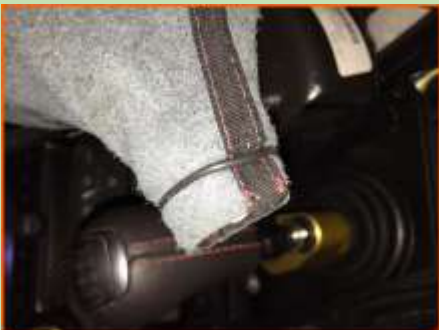
The leather boot is held to that plastic chrome trim with two small staples. I did not have this come loose but a he said his boot did. A responder stated: *"The staples come out very easily. Best fix is to take the shift knob off, then pop the entire boot off. Turn it inside out and use picture hanging wire to secure it to the chrome ring. There is a groove that the wire will fit in well."* After seeing the above note in this report, another forum member sent the pic left and said he found the metal ring shown holding the chrome trim ring. Appears there may be differences depending on year or production date.

Suggest you take care when pushing the ring down and it should not come loose.

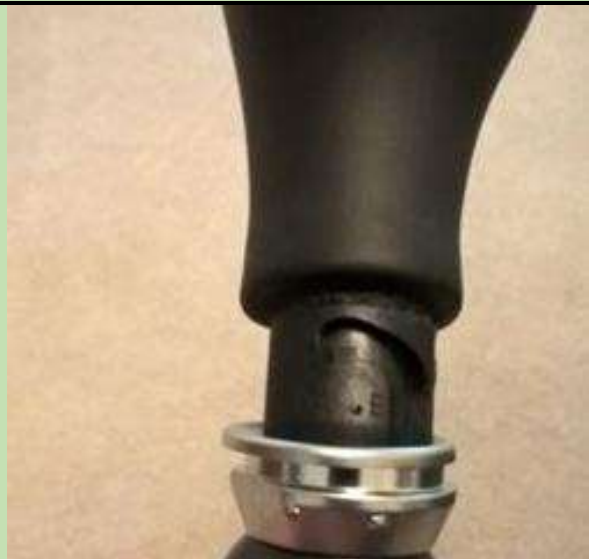
First thing that happened was it appeared very easy to turn the chrome ring! Well no it turned out what I found easy to move was the leather was moving and came loose from the chrome ring!

In fact this is a pic from a poster on the Forum. It shows something similar to what I saw a chrome ring separated from the leather boot! Not the first thing I wanted!

Thank goodness in a post where that happened to someone where members were saying you need to remove the console top to get access than staple the two tighter. In fact looks like two staple holes below the ring slot. I saw what looked like one side of a large staple but it must have fallen down.

Fortunately someone said; instead of all that work why not use Gorilla glue! Gave me an idea, use my favorite adhesive,-5 minute epoxy! Dry fit the parts and the top of the leather boot slipped in the groove fine. Mixed some epoxy and with a tooth pick carefully placed in in the groove and pulled up the leather boot. Left it overnight.

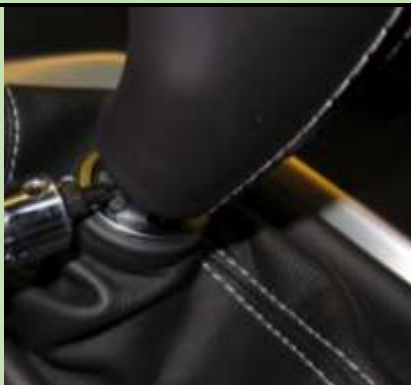
This is from a forum post but what my screw looked like. It required a small #15 Torx bit.

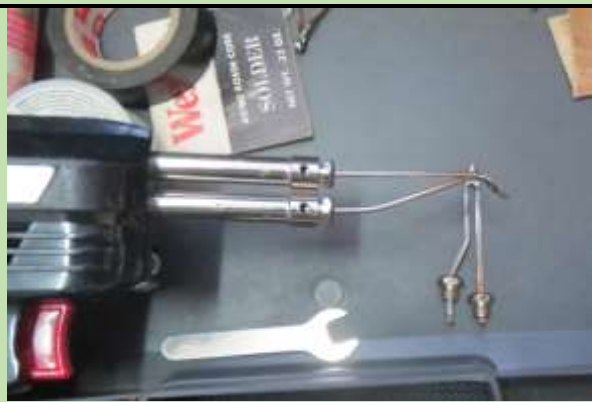
Another pic from a forum post but similar what I did using a Torx bit and a 1/4 inch drive ratchet wrench

It looked like the screw was rounding so stopped and bought a new #15 Torx wrench.

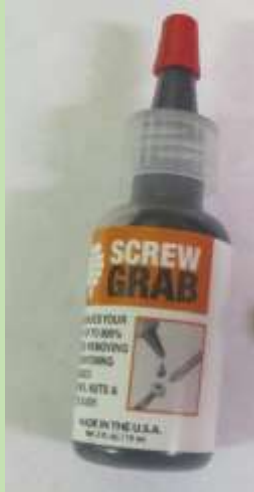
Thinking they may have used a Red type Loctite I readied my soldering iron and shaped the flat tip to fit the screw

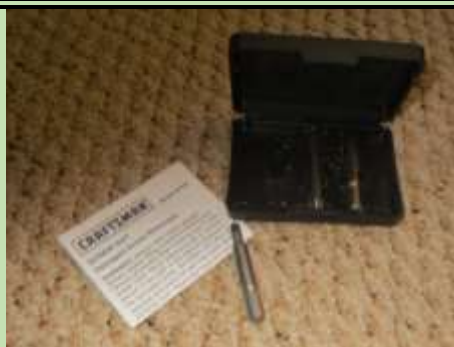
No choice it was not turning so drilled a small hole and used a product called Screw-Out. It is made of hardened steel and has sharp edges that bit into the hole. Still would not budge.

Movement, not the screw as hoped - the head sheared from the screw! Screwed!!

Thought even then need to drill out the screw and install a bolt if necessary until the shift kit arrives. When drilling out the screw body realized it was not as long as the new screw provided. There were 4 or 5 threads left in the shifter shaft that were visible and unharmed

It worked, the new Allen screw held firmly. Had some difficulty getting the pins in the chrome ring to slip in both grooves. If one lined up the other was off perhaps 10 degrees. Had to start one pin and then turn the ring forcing the pin in the other groove.

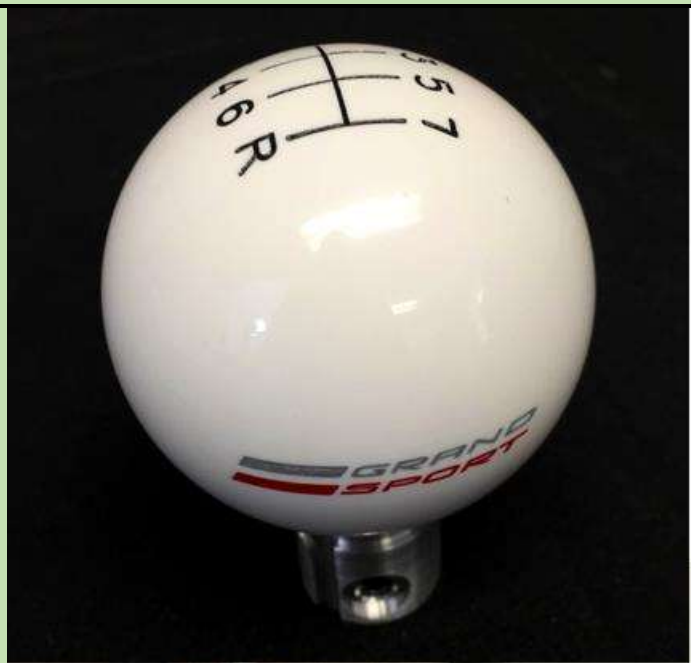
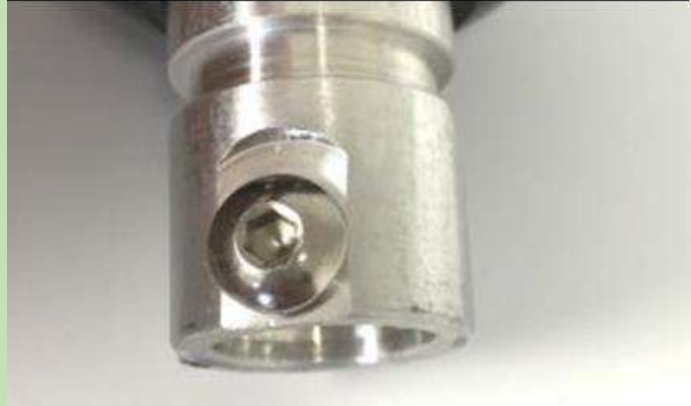
Tried to use one of the "O" Rings but that made it tougher to get both pins up to the top groove. Unlike the OEM knob, there is no slightly raised area to keep the chrome ring from turning. Needed something to keep the chrome ring from turning and keep the pins snug in the groove.

The solution with our white knob was a small amount of white silicone placed in the groove prior to the pins being fully up and then turned. Put some in with a toothpick, then pulled the pins fully up and turned ~90 degrees to have the seams line up properly.

Used some string around the leather boot and let the silicone dry overnight.
