Rear Muffler Panel “Rust” on 2014 C7 and 2017 Grand Sport

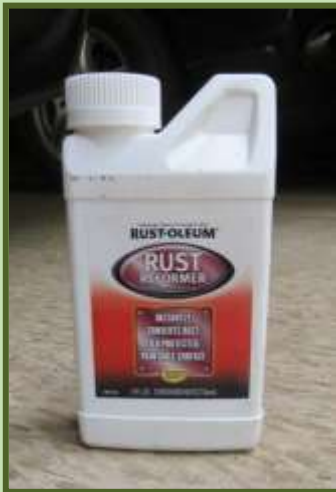
The rust is only visible on the rear muffler panel. With four, 4 inch OD 304 polished stainless muffler tips filling the center opening there is not much visibility behind them. I considered painting the parts black, in fact bought an 8 ounce can of black high temperature barbecue paint. However looking at the access, unless the rear bumper was removed, it would very difficult to paint. Also, my experience with painting exhaust systems indicated if not applied very thinly it can peel. Using a spray can is not possible without removing the bumper.

A better solution was to use a rust converter or rust reformer. I purchased an 8 ounce container at Walmart for just over \$5.00. This product is not like paint. It has the consistence of milk and is applied very simply. It only changes the brown rusted areas to a dull black. It does not affect areas that are not rusted. If the material has loose flaky rust, it should be removed with a wire brush. But the tight rust on the 409 did not need prior cleaning.

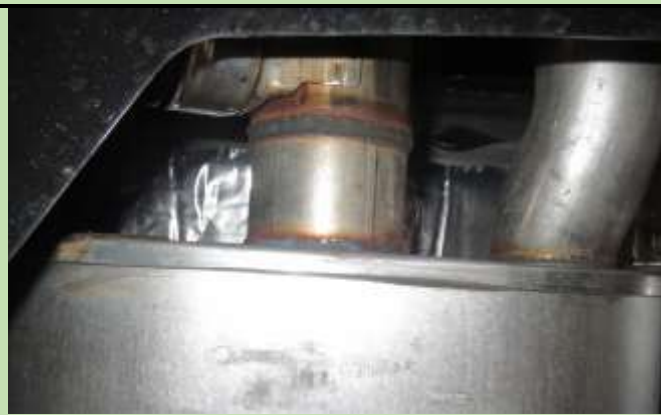
Even better than 409 welding wire is a heavily alloyed wire called 307. It not only has 18% chrome and 8% nickel it contains high manganese, 6%. This keeps the deposit ferritic so it can be used to weld 409 or 304. It can be also be used to weld 409 to 304 stainless steel or even carbon steel. This alloy is more commonly used in Europe, where it is considered the gold standard for welding muffler steels.

Perhaps Chevy should consider requiring 307 type welding wire for back panel welds to have more rust-free deposits.
