Rear Muffler Panel “Rust” on 2014 C7 and 2017 Grand Sport

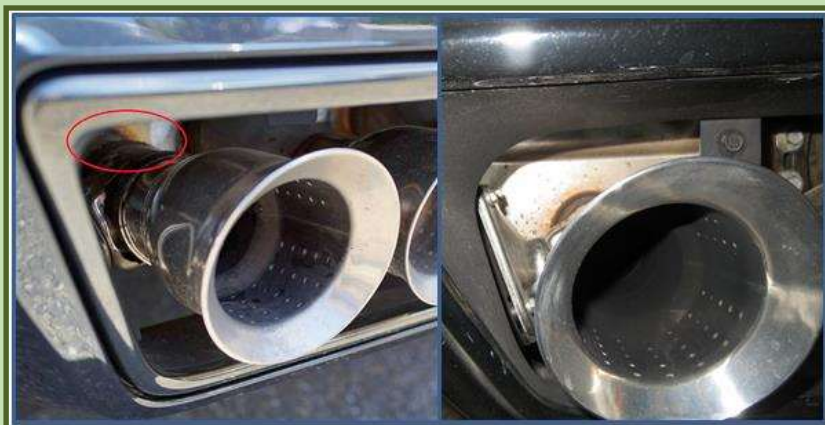
A forum poster asked about the brown stain he observed on the rear panel of his mufflers (red circle picture left.) I recalled seeing the same brown stain in a number of areas on my C7. I responded to his post indicating I used a product called Rust-Olium

Rest Reformer to change the brown, “rust” black (the picture right is a similar area I coated 6 months ago.) These products have been sold for many years. They convert iron oxide (rust) to iron titanate using tannic acid and pH adjusters. This product also contains barium sulfate and a future rust inhibitor.

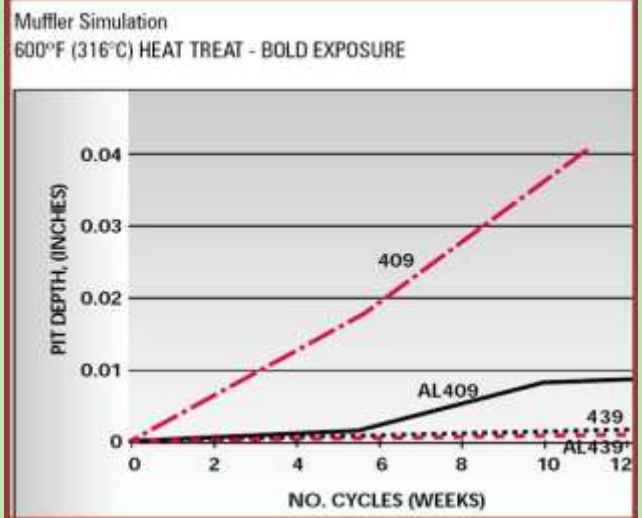
This is a graph provided by the aluminized stainless steel manufacturer showing what they referred to as bold exposure. It quantifies corrosion by measuring and plotting the depth of pits that form over the exposure time. Note the aluminized 409 stabilized at under 0.01 inch deep pits while the uncoated material progressively formed deeper pits. Plain carbon steel would be significantly worse.

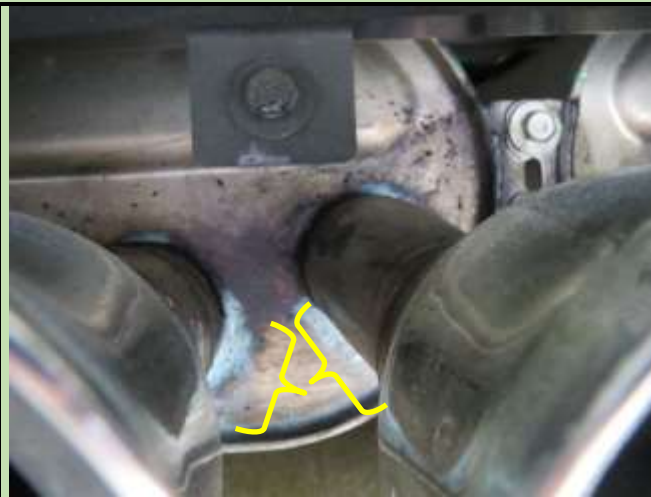
This is what was I used to gain brush access to the back muffler panels and welds. A small metal handle disposable brush was taped to a small rod so access to the rusted areas could be made mostly from the rear. No reason to jack up the car just lay on your side. A small amount of Rust Reformer was placed in a paper cup. You don't need much. It is indicated the product has a shelf live and it should be not used after about a year.

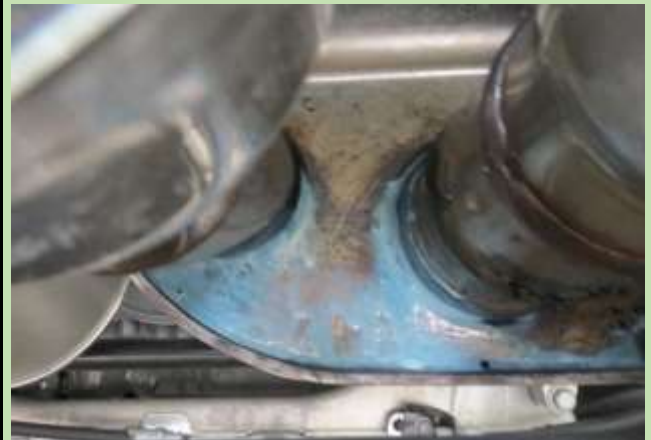
This picture was taken after a few brush strokes were made over the rusted area. Two areas are marked in yellow. The milk like, somewhat foamy reformer looks light blue in this picture as well as the one below. It is best to put on some light coats than come back and repeat in a few minutes.

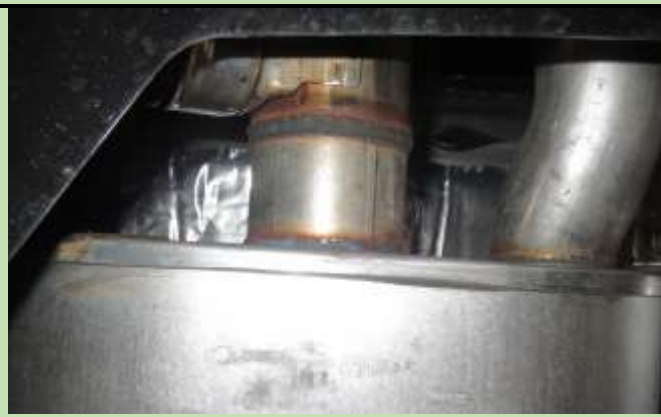
My 2-month-old Grand Sport looked about the same at my 2014 C7. The welds and the HAZ around the welds that removed the aluminized surface had rusted. It was not flaky rust so all that was needed was a quick wipe with a rag.

The same rust was on both mufflers. All on the welds and the weld HAZ (Heat Affected Zone) next to the weld. The heat melted the very thin aluminized layer on the 409-stainless steel.

Rust reformer applied with a brush taped to a dowel. Mostly all from the rear. It took less than 10 minutes.

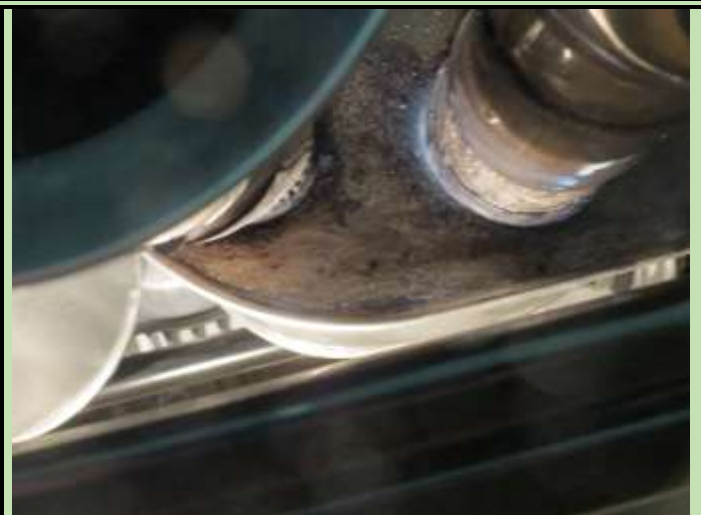
After about a half hour all rust turned a blue black. A second coat is recommended. I found it does little but does catch some spots that may have been missed. Where there is not rust there is no evidence the Rust Reformer was applied.

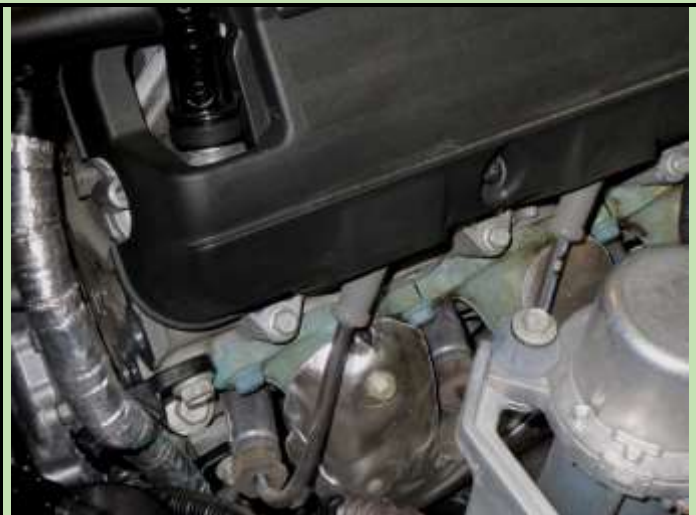
After 2 coats, waiting 15 minutes between, this is the appearance after the last coat dried for an hour. Still blue but looking better than rust. We'll see if, like the muffler, it turns blacker after a day and particularly when the exhaust gets hot. Hopefully it will retain the reduced rust finish after it has operated for a while.
