Shift Knob Feels Great, Looks Cool and Shortens Throw!

Picture Install:

Install on 2014 C7

Install on 2017 GS

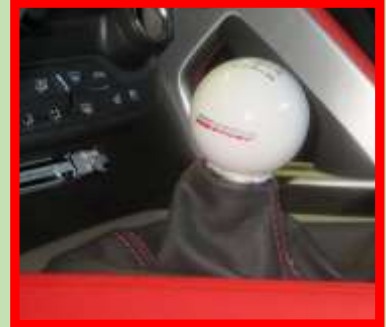
This “Cue Ball” size shift knob is available for the C7. Had the black one (left) on my Red 2014 Z51 C7 and installed the white knob (right) on my Artic White 2017 Grand Sport.

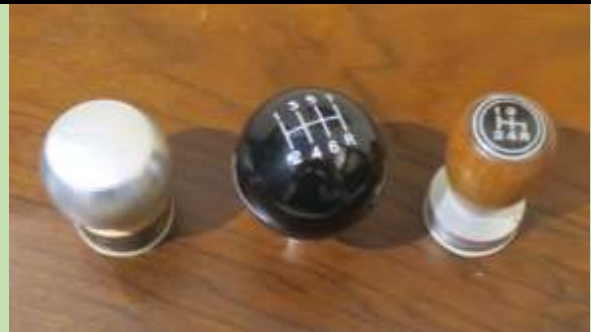
The knob is large, $2\frac{1}{4}$ inch diameter, the same size as a cue ball!

This picture shows a comparison with my desk paperweight knobs from my 1974 Datsun 260Z and a knob from a short throw B&M shifter installed in my S-10 truck some years ago.

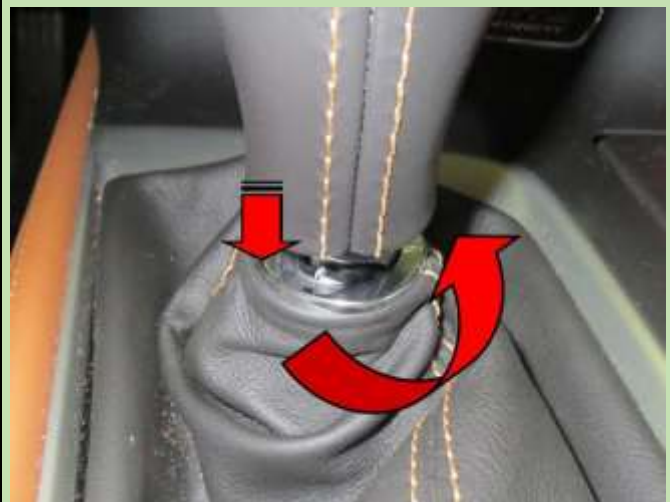
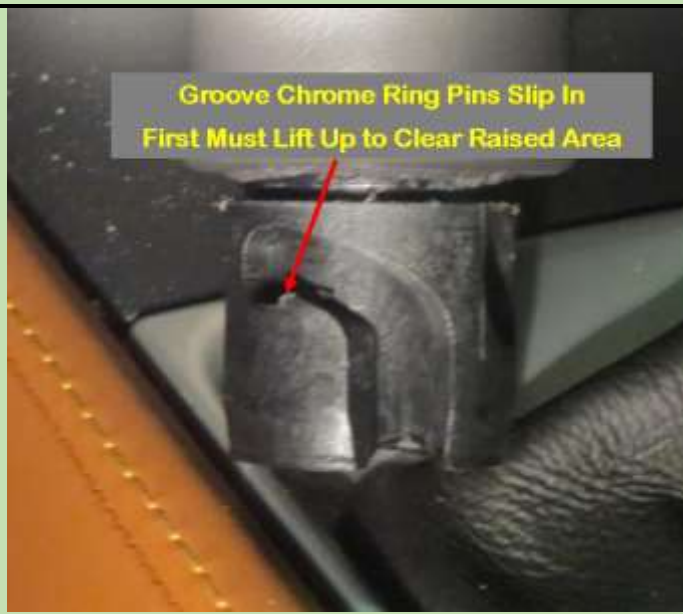
First, with the knob removed you can see the grooves that are on both sides of the OEM shift knob. That is the path two pins attached to the trim ring must follow it have it slide down to reveal the screw holding the knob in place.

There is a slight raised ridge (red arrow) that must be cleared before pressing the ring down in the groove. I think getting over that ridge was the problem I had because in my shifter the pins fit very tight in the grooves. Perhaps yours will have more clearance.

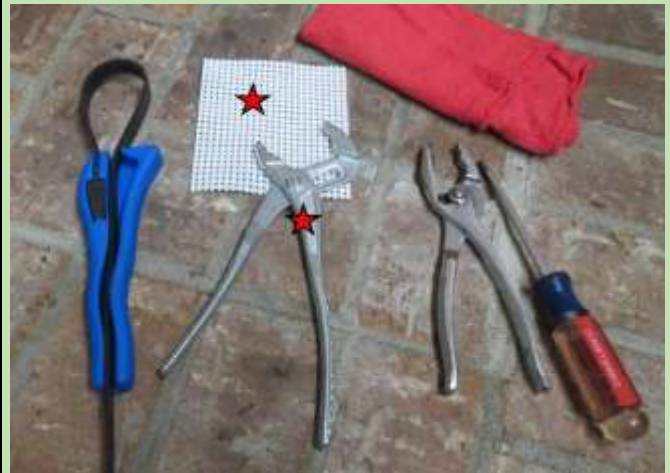
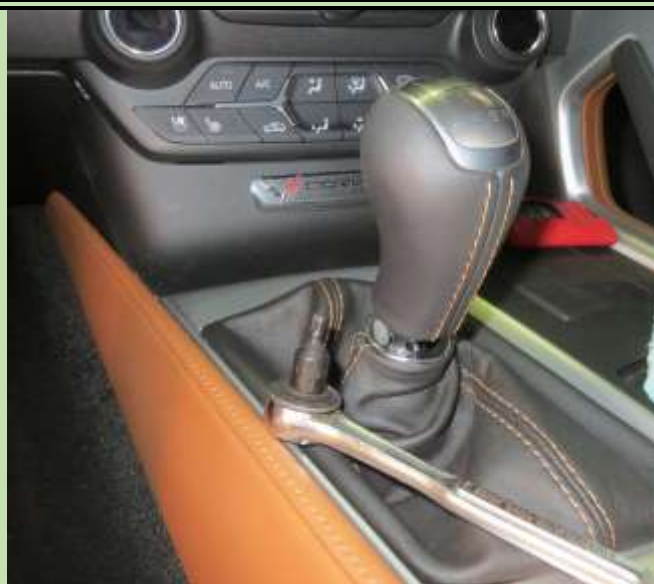
These are the tools I used trying to turn the trim ring! On the left is a rubber pipe wrench, which was not help. I even used a screw driver to leverage it down, don't do that, it won't help! Used a rag and the pliers shown next to the screw driver-no help. The best I could do was to get it to turn about 10 to 15 degrees when 90 degrees was needed!

Finally used the arc joint pliers (shown with the red star) and the jar friction pad (also shown with a red star.) The pad provided friction and well as protected the leather and chrome ring. It worked. Took quite a bit of force but it finally turned.

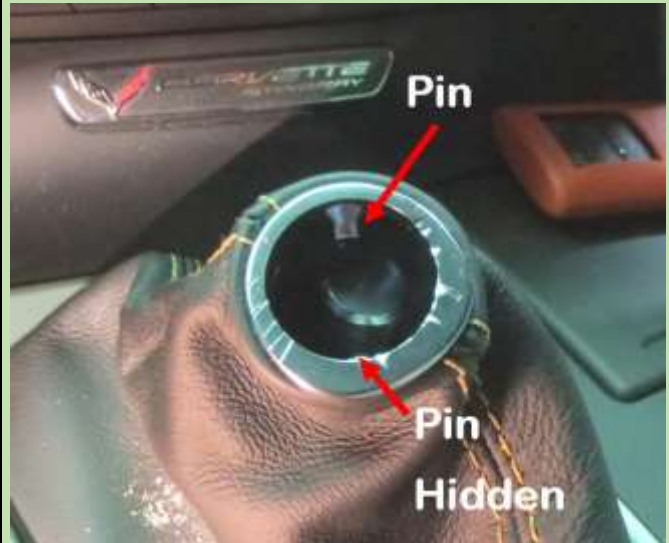
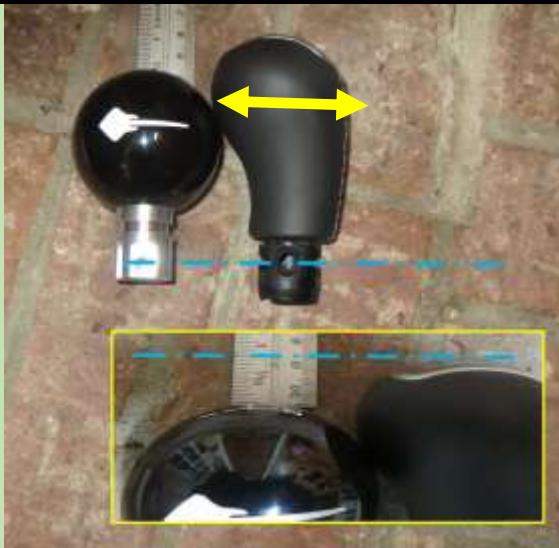
After the OEM knob was removed, this pic shows one of the pins that is part of the ring. There is a similar pin (hidden from view in this pic) on the opposite side.

These are the two knobs side by side. Lining up the screw holes and measuring the max height shows about $\frac{3}{4}$ inches, not a full 1 inch height difference. The OEM knob is 2 inches wide and 2.07 inches front to back.

Considering I also had some difficulty reinstalling the trim ring, I could have used an emery board and sanded both pins slightly to provide more clearance. Perhaps your pins will be easier to slide in the grooves.

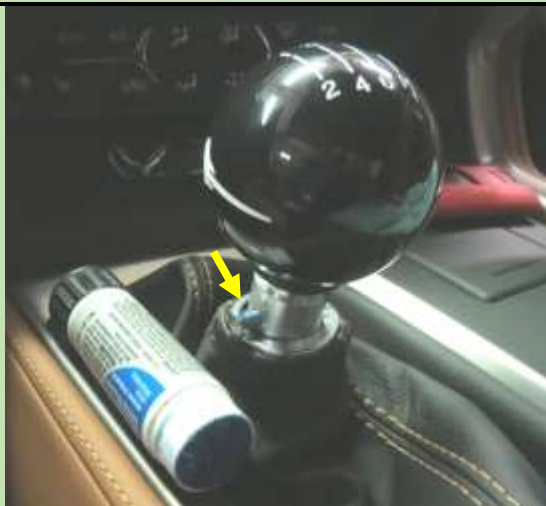
I put blue, medium strength Loctite on the screw that attaches the new knob to the shaft (yellow arrow.)

If you have not used these stick Loctite products, they are great! In this instance I used a toothpick to apply to the screw. The screw uses a 3 mm Allen wrench, which allowed a good deal of force to be used when tightening.

The new knob has the same two pin grooves as the OEM knob (red arrow.) The pins on the trim ring need to ride in these grooves as it is raised in position. The pins fit tight and required significant force to have them move up to the top. Just wiggle as you pull up.

Note the knob came with 3 "O" rings to choose from that slip above the pin groove. It helps keep the trim ring snug. The thinnest of the 3 was used and with the tight pin fit, not sure even if it was required.

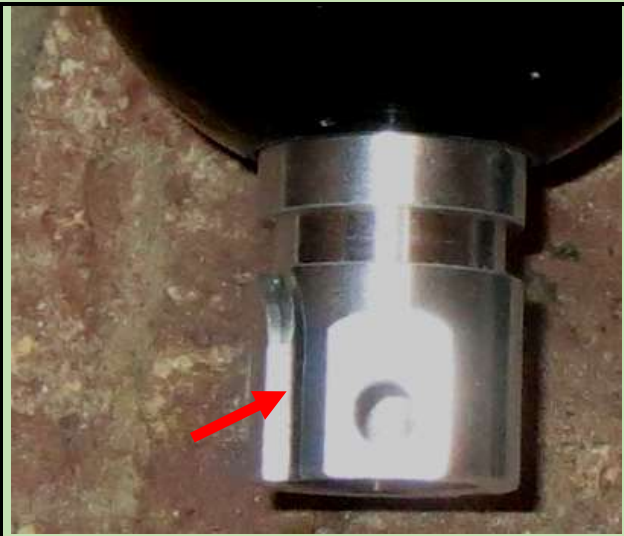
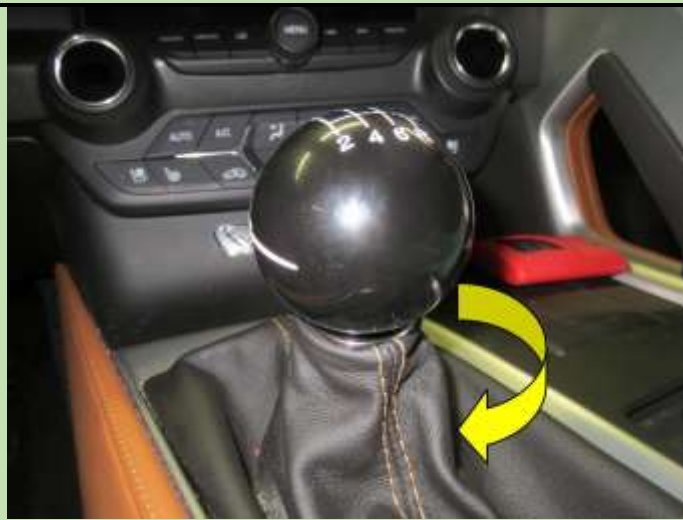
Once the knob is secured, the chrome trim ring is reinstalled. When fully up to the top it required the same arc joint pliers and the friction pad used to remove it, to rotate the ring in the final position. Not the best design especially since it appears it is only made of plastic.

Measuring the shifter throw with the new knob shows it was $2 \frac{7}{16}$ inches. That is $\frac{5}{16}$ inches less than the OEM shifter or $0.31/2.75 = 11.4\%$ less.

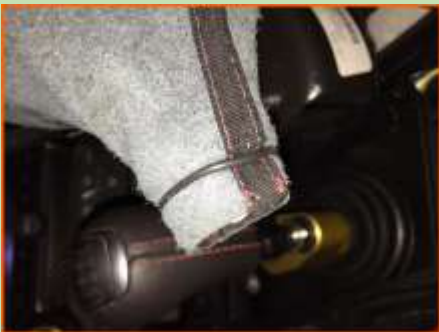
The leather boot is held to that plastic chrome trim with two small staples. I did not have this come loose but a he said his boot did. A responder stated: *"The staples come out very easily. Best fix is to take the shift knob off, then pop the entire boot off. Turn it inside out and use picture hanging wire to secure it to the chrome ring. There is a groove that the wire will fit in well."* After seeing the above note in this report, another forum member sent the pic left and said he found the metal ring shown holding the chrome trim ring. Appears there may be differences depending on year or production date.

Suggest you take care when pushing the ring down and it should not come loose.

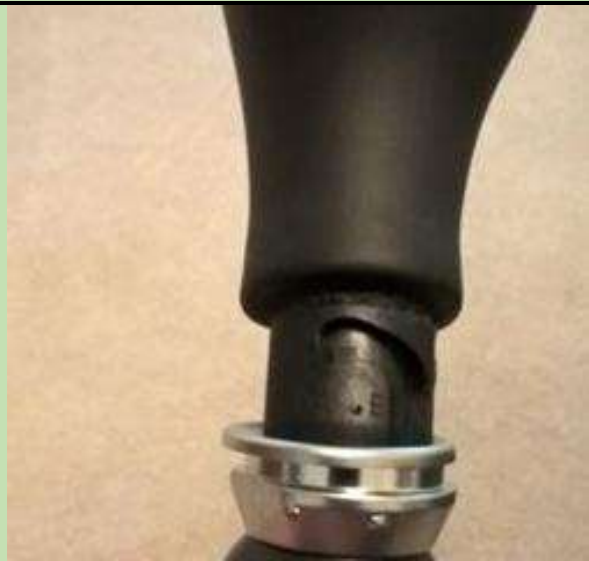
First thing that happened was it appeared very easy to turn the chrome ring! Well no it turned out what I found easy to move was the leather was moving and came loose from the chrome ring!

In fact this is a pic from a poster on the Forum. It shows something similar to what I saw a chrome ring separated from the leather boot! Not the first thing I wanted!

Thank goodness in a post where that happened to someone where members were saying you need to remove the console top to get access than staple the two tighter. In fact looks like two staple holes below the ring slot. I saw what looked like one side of a large staple but it must have fallen down.

Fortunately someone said; instead of all that work why not use Gorilla glue! Gave me an idea, use my favorite adhesive,-5 minute epoxy! Dry fit the parts and the top of the leather boot slipped in the groove fine. Mixed some epoxy and with a tooth pick carefully placed in in the groove and pulled up the leather boot. Left it overnight.

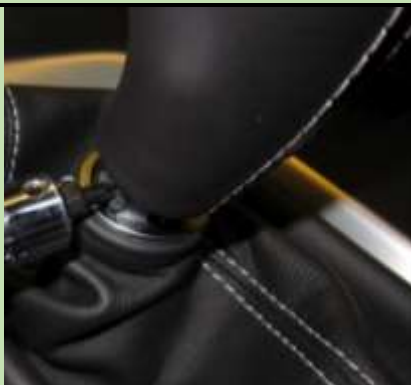
This is from a forum post but what my screw looked like. It required a small #15 Torx bit.

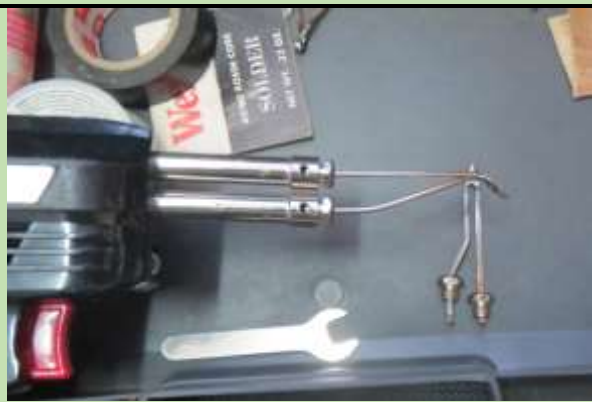
Another pic from a forum post but similar what I did using a Torx bit and a 1/4 inch drive ratchet wrench

It looked like the screw was rounding so stopped and bought a new #15 Torx wrench.

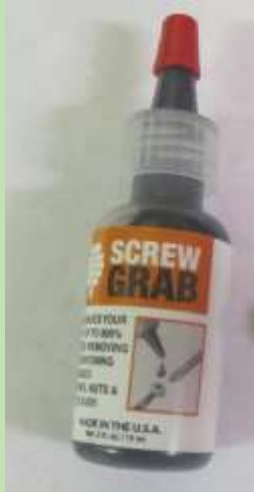
Thinking they may have used a Red type Loctite I readied my soldering iron and shaped the flat tip to fit the screw

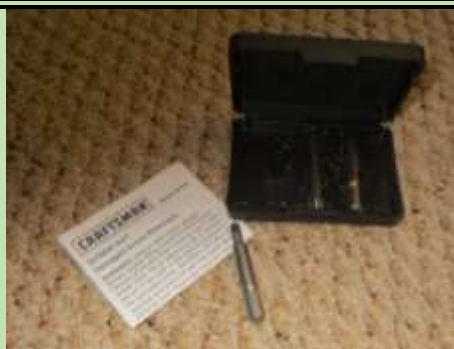
Sheared Screw Head !!

No choice it was not turning so drilled a small hole and used a product called Screw-Out. It is made of hardened steel and has sharp edges that bit into the hole. Still would not budge.

Then placed a drop of this black toothpaste consistence Screw Grip on the Screw-Out!

Movement, not the screw as hoped - the head sheared from the screw! Screwed!!

Thought even then need to drill out the screw and install a bolt if necessary until the shift kit arrives. When drilling out the screw body realized it was not as long as the new screw provided. There were 4 or 5 threads left in the shifter shaft that were visible and unharmed

It worked, the new Allen screw held firmly. Had some difficulty getting the pins in the chrome ring to slip in both grooves. If one lined up the other was off perhaps 10 degrees. Had to start one pin and then turn the ring forcing the pin in the other groove.

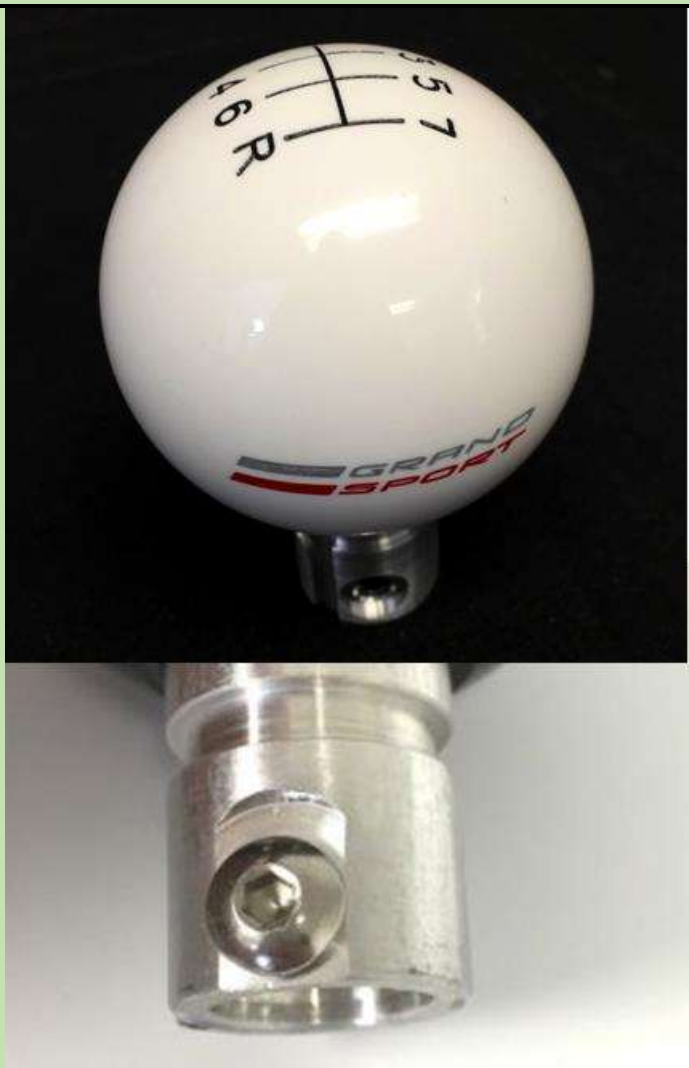
The solution with our white knob was a small amount of white silicone placed in the groove prior to the pins being fully up and then turned. Put some in with a toothpick, then pulled the pins fully up and turned ~90 degrees to have the seams line up properly.

Used some string around the leather boot and let the silicone dry overnight.

Snug as a bug in a rug!
