Shift Knob Feels Great, Looks Cool and Shortens Throw!

Install on 2014 C7

Install on 2017 GS

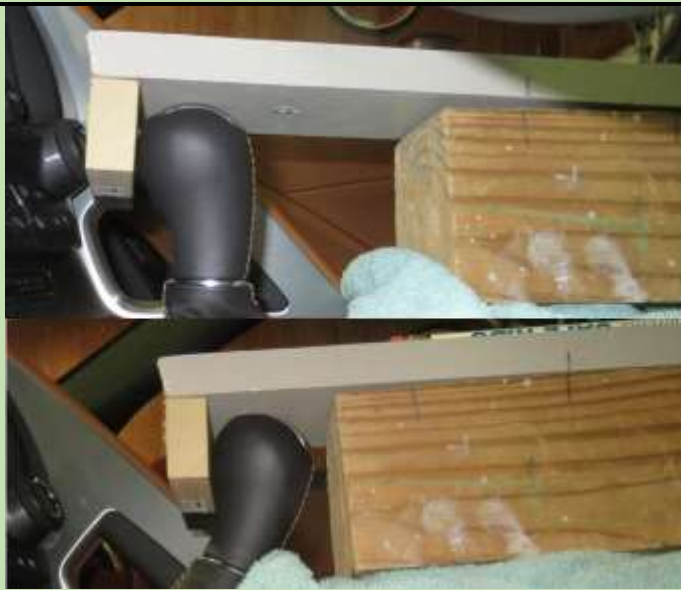
First task was to devise a way to measure the existing shifter throw. Decided since one often uses a cupped hand to pull the shifter back, the measurement method shown probably best defines the stroke. I used a section of wood that was perpendicular to the top board, simulating a cupped hand touching the knob. Marking the bottom block from the shift knob furthest forward to full back showed the standard shifter has a 2 ³/₄ inch throw.

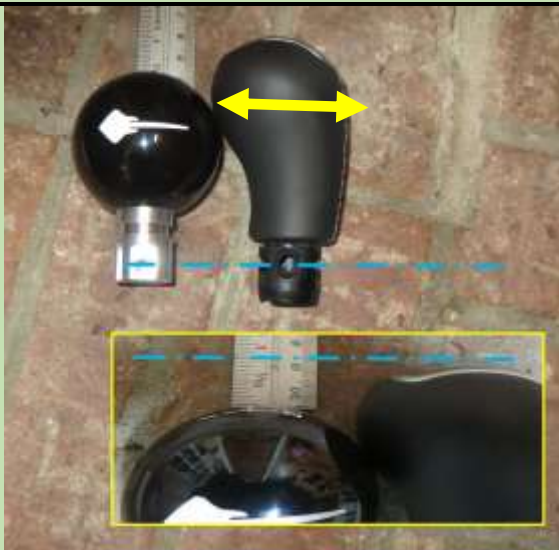
These are the two knobs side by side. Lining up the screw holes and measuring the max height shows about $\frac{3}{4}$ inches, not a full 1 inch height difference. The OEM knob is 2 inches wide and 2.07 inches front to back.

The new knob is $2\frac{1}{4}$ inch diameter. It feels fine in my hand. I don't have long fingers but the width for a glove measurement is $9\frac{1}{2}$ inches which is a large to extra-large glove size.

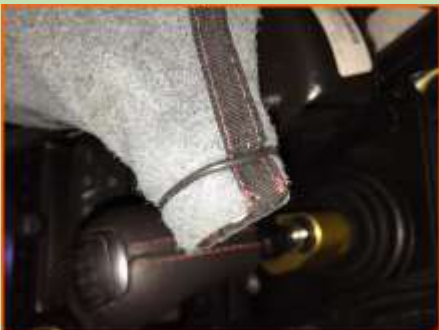
The leather boot is held to that plastic chrome trim with two small staples. I did not have this come loose but a he said his boot did. A responder stated: *"The staples come out very easily. Best fix is to take the shift knob off, then pop the entire boot off. Turn it inside out and use picture hanging wire to secure it to the chrome ring. There is a groove that the wire will fit in well."* After seeing the above note in this report, another forum member sent the pic left and said he found the metal ring shown holding the chrome trim ring. Appears there may be differences depending on year or production date.

Suggest you take care when pushing the ring down and it should not come loose.

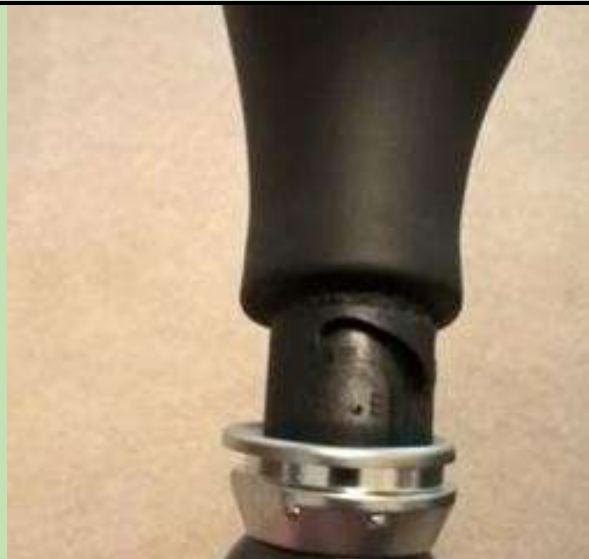
First thing that happened was it appeared very easy to turn the chrome ring! Well no it turned out what I found easy to move was the leather was moving and came loose from the chrome ring!

In fact this is a pic from a poster on the Forum. It shows something similar to what I saw a chrome ring separated from the leather boot! Not the first thing I wanted!

Thank goodness in a post where that happened to someone where members were saying you need to remove the console top to get access than staple the two tighter. In fact looks like two staple holes below the ring slot. I saw what looked like one side of a large staple but it must have fallen down.

Fortunately someone said; instead of all that work why not use Gorilla glue! Gave me an idea, use my favorite adhesive,-5 minute epoxy! Dry fit the parts and the top of the leather boot slipped in the groove fine. Mixed some epoxy and with a tooth pick carefully placed in in the groove and pulled up the leather boot. Left it overnight.

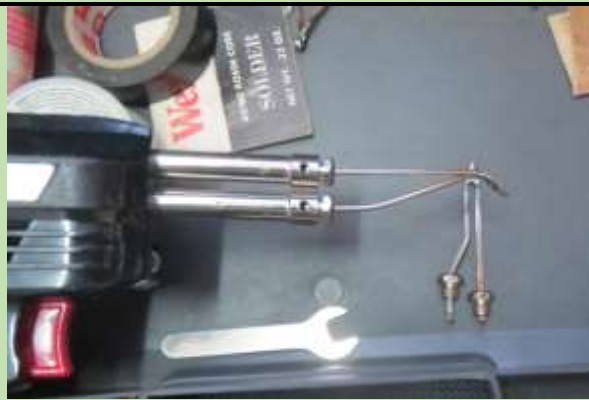
Thinking they may have used a Red type Loctite I readied my soldering iron and shaped the flat tip to fit the screw

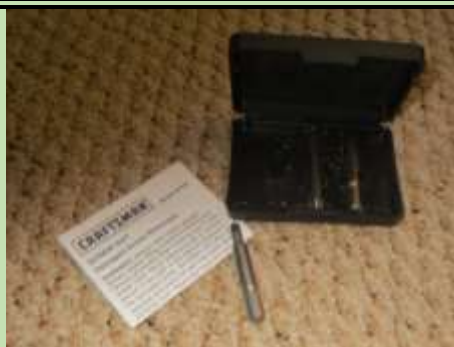
No choice it was not turning so drilled a small hole and used a product called Screw-Out. It is made of hardened steel and has sharp edges that bit into the hole. Still would not budge.

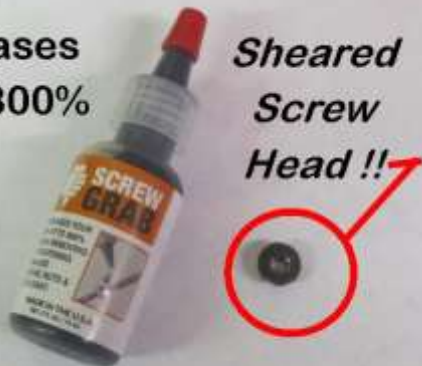
Sheared Screw Head !!

Then placed a drop of this black toothpaste consistence Screw Grip on the Screw-Out!

Movement, but not the screw as hoped! The head sheared from the screw! Screwed!!

Thought even then need to drill out the screw and install a bolt if necessary until the shift kit arrives. When drilling out the screw body realized it was not as long as the new screw provided. There were 4 or 5 threads left in the shifter shaft that were visible and unharmed

It worked, the new Allen screw held firmly. Had some difficulty getting the pins in the chrome ring to slip in both grooves. If one lined up the other was off perhaps 10 degrees. Had to start one pin and then turn the ring forcing the pin in the other groove.

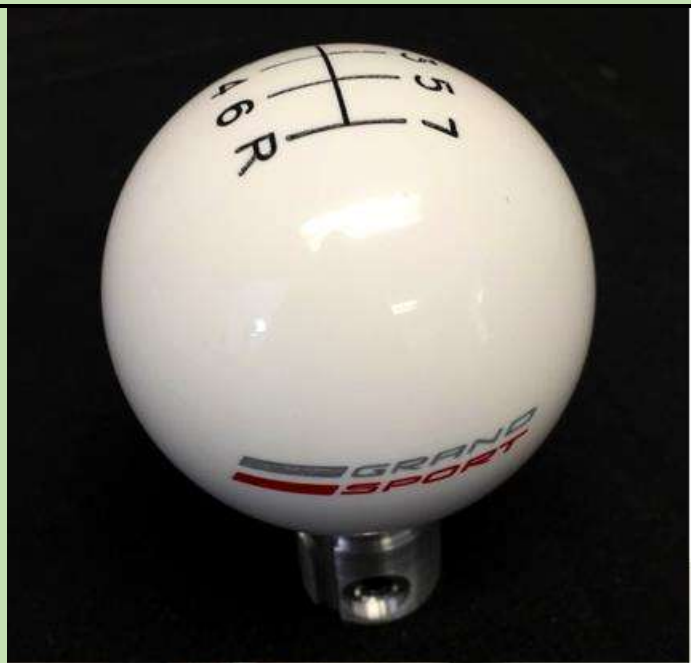
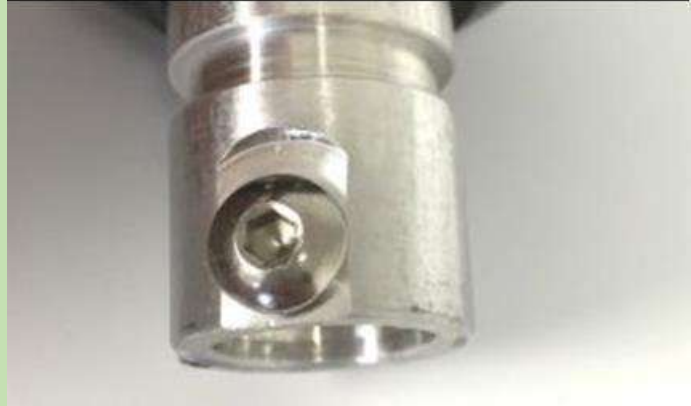
Tried to use one of the "O" Rings but that made it tougher to get both pins up to the top groove. Unlike the OEM knob, there is no slightly raised area to keep the chrome ring from turning. Needed something to keep the chrome ring from turning and keep the pins snug in the groove.

The solution with our white knob was a small amount of white silicone placed in the groove prior to the pins being fully up and then turned. Put some in with a toothpick, then pulled the pins fully up and turned ~90 degrees to have the seams line up properly.

Used some string around the leather boot and let the silicone dry overnight.
